# Manhole Inspection Summary

Manhole # S25E\_\_056MH

**Location** Address: **310 CALHOUN-CAREY**

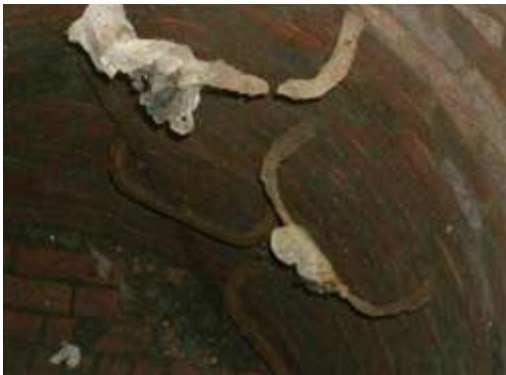
Defect 2

**Surcharge** ☒ **Evidence Of Surcharge** Depth: **6** (ft.) ☐ Active Surcharge Present

CORRODED STEPS AND EVIDENCE OF ASUR

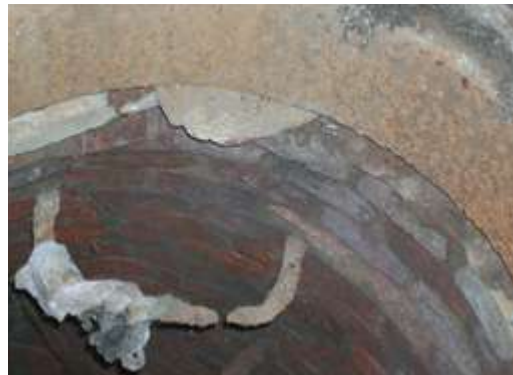
Defect 1

Condition: ☐ Sound ☐ Cracked ☐ Root Intrusion ☐ Loose Brick ☒ **Deteriorated**

DETERIORATION OF CHIMNEY

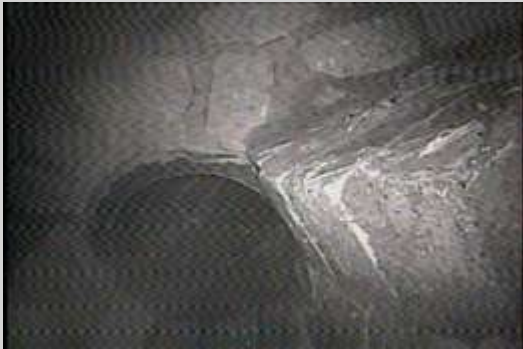
12 O'Clock Outflow

Pipe Height: **8.4** (in.) Rod and Bar (Angled)  
Pipe Material: **Clay** ☐ Pipe Lined  
Invert Depth: **8.08** (ft.) Flow Characteristics: **Slow**  
Deposits: ☒ None ☐ Mud ☐ Sludge ☐ Debris ☐ Grease  
Silt Depth: (in.) Deposits Extent:  
Infiltration: **None** Pipe Seal Cond: **Sound**

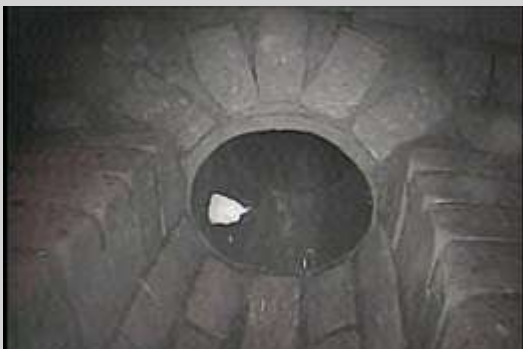
3 O'Clock Inflow

Pipe Height: **8.4** (in.) Rod and Bar (Angled)  
Pipe Material: **Clay** ☐ Pipe Lined  
Invert Depth: **7.95** (ft.) Flow Characteristics: **Slow**  
Deposits: ☒ None ☐ Mud ☐ Sludge ☐ Debris ☐ Grease  
Silt Depth: (in.) Deposits Extent:  
Infiltration: **None** Pipe Seal Cond: **Sound**

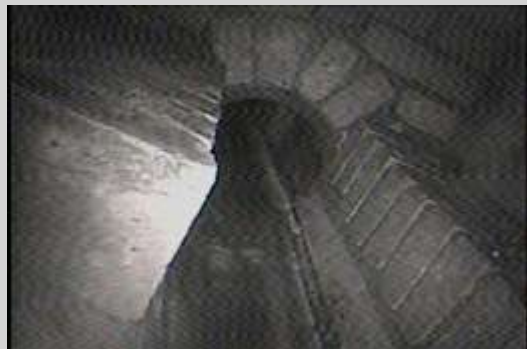
6 O'Clock Inflow

Pipe Height: **7.2** (in.) Rod and Bar (Angled)

Infiltration: **None** Pipe Seal Cond: **Sound**
